City of **SUN VALLEY**
Transportation Plan

November 21, 2014

KELLER
associates

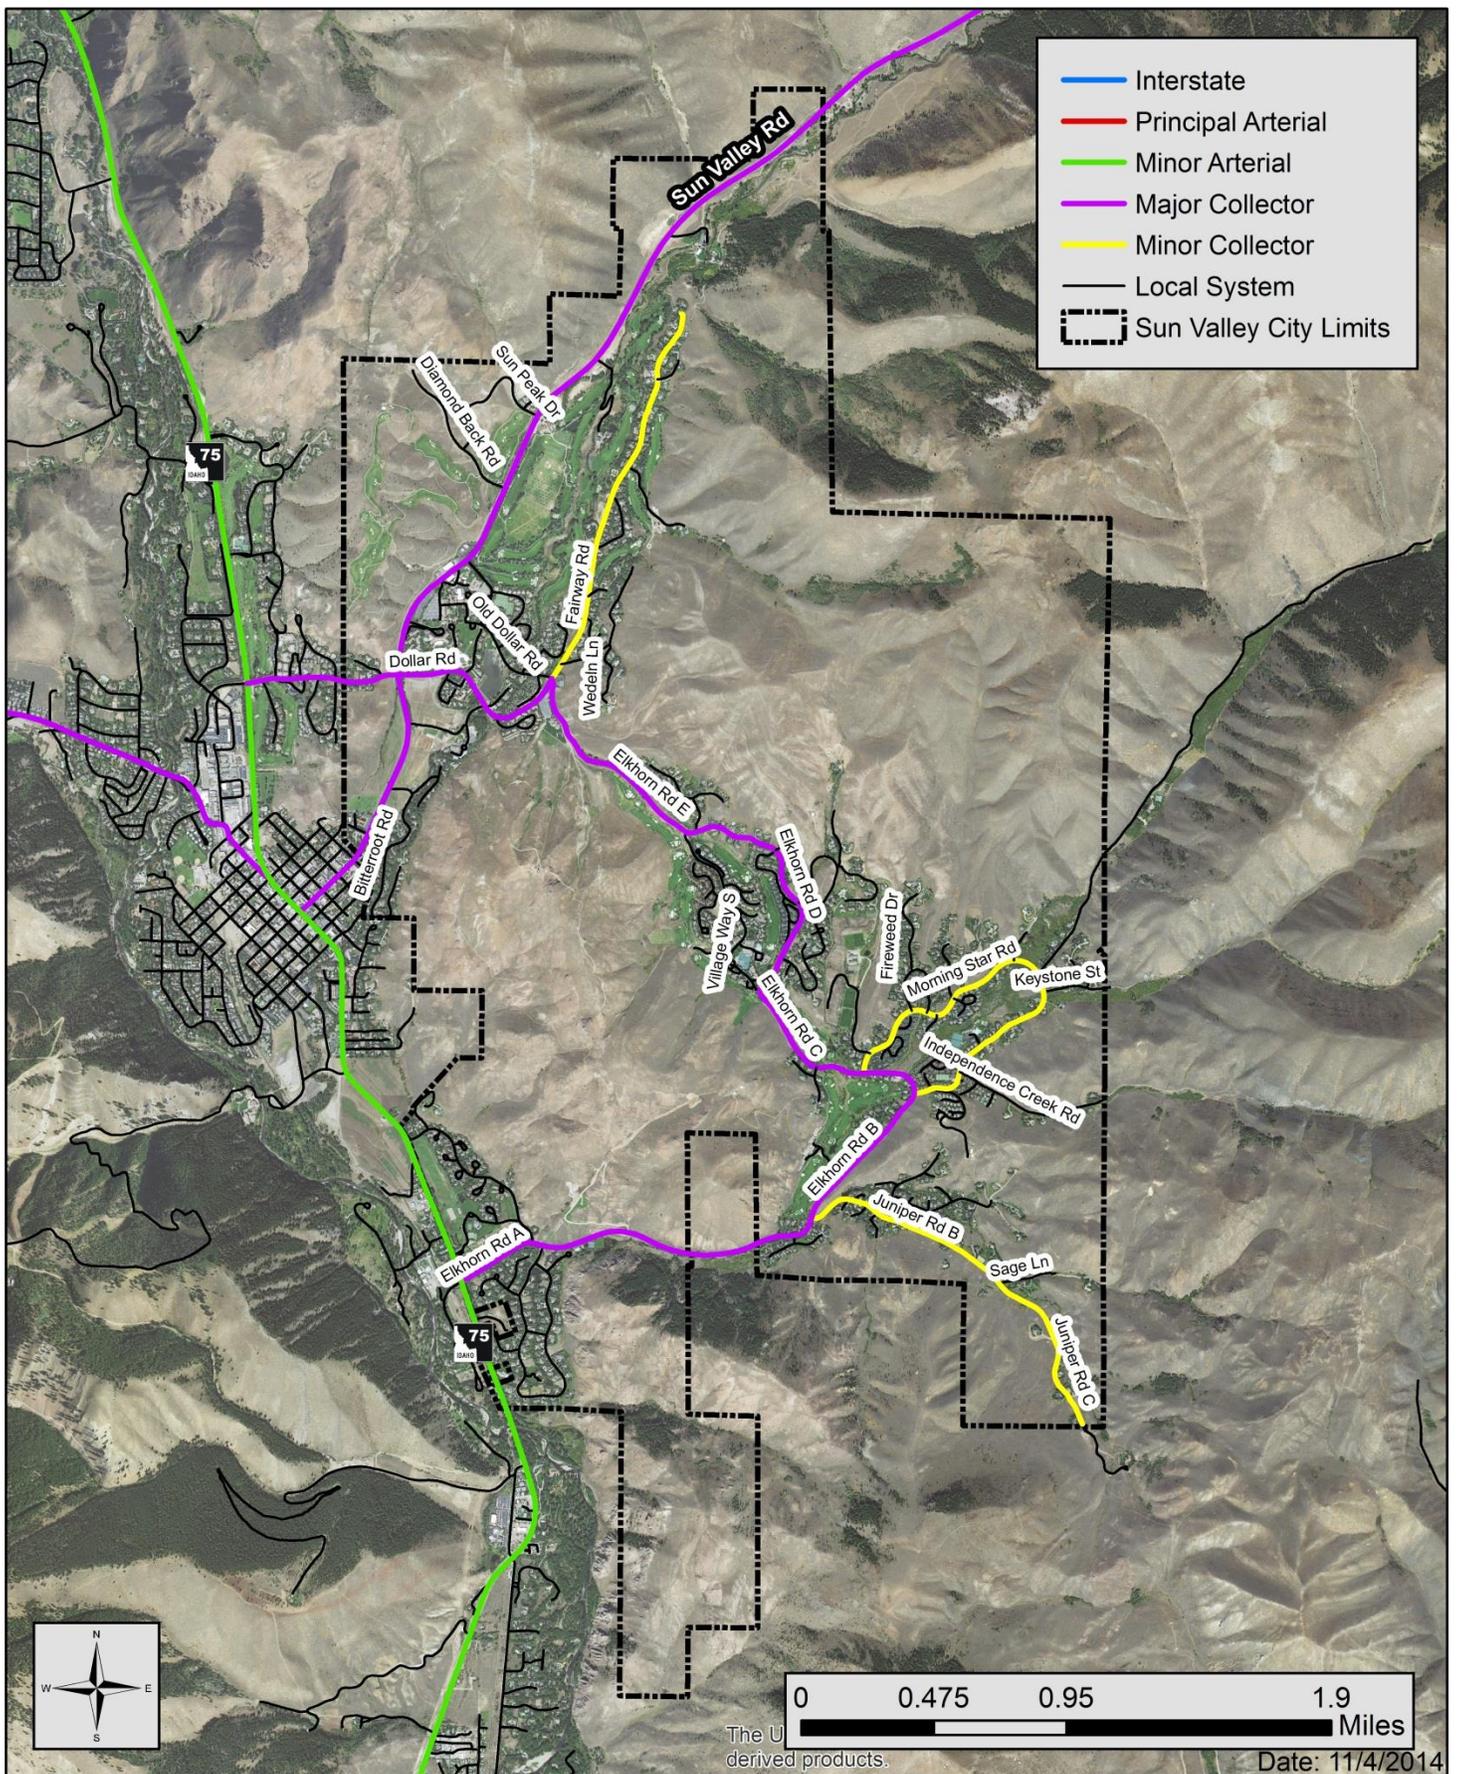
Figure 9 - Recommended Functional Classification

mentioned streets. This process involves submitting an Idaho Functional Classification/Urban Boundary Change Request Form to ITD. This form requires information about the roadway and justification for the request. Excerpts from the ITD 2014 Systems Manual regarding Functional Classification updates can be found in Appendix A¹. Recommended classifications are illustrated in Figure 9.

Saddle, Dollar, and Elkhorn Roads, which provide access to local roads between SH-75 and Sun Valley Road, should be classified as Major Collectors. Elkhorn Road is the main means of access to Dollar Mountain amenities and the Elkhorn Village area. It also serves as a de facto SH-75 “bypass route” when road work and other causes of delay occur on SH-75. Fairway, Morning Star, and Juniper Roads, which provide access to many local roads along their rights-of-way, could potentially be classified as Minor Collectors.

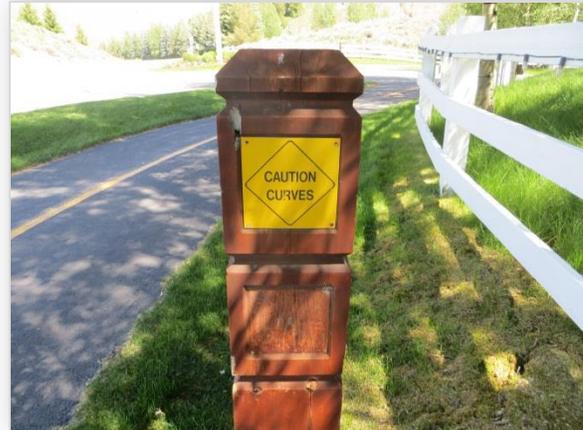
Picture 1 - Typical Bollard

Pathways in Sun Valley are asphalt paths, typically 12 feet wide. Paths along Diamond Back Rd. and Sun Peak Dr. in the White Cloud development are brick pavers. They are in City right-of-way but are maintained by the local home owners association. Traffic control on pathways is provided by wooden bollards with plaques. Bollard and pathway pavement conditions were inventoried; pathway pavement conditions and maintenance analysis are discussed in Section 6.1.4. Refer to Appendix D for a copy of the bollard inventory and photos.

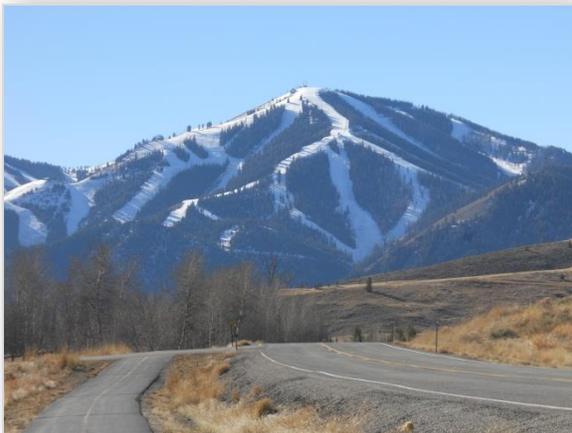
Picture 3 - Separated Pathway

Paths immediately adjacent to roads are two-way, which results in cyclists moving in the opposite direction of adjacent motorist traffic. This is problematic at intersections, where motorists typically do not expect bike traffic from the direction opposite of motor traffic. This issue is identified in the Blaine County Bicycle and Pedestrian Master Plan. The Bike/Ped Master Plan recommends that if new adjacent pathways are constructed, they should be one-way in the direction of adjacent traffic and located on both sides of the street.

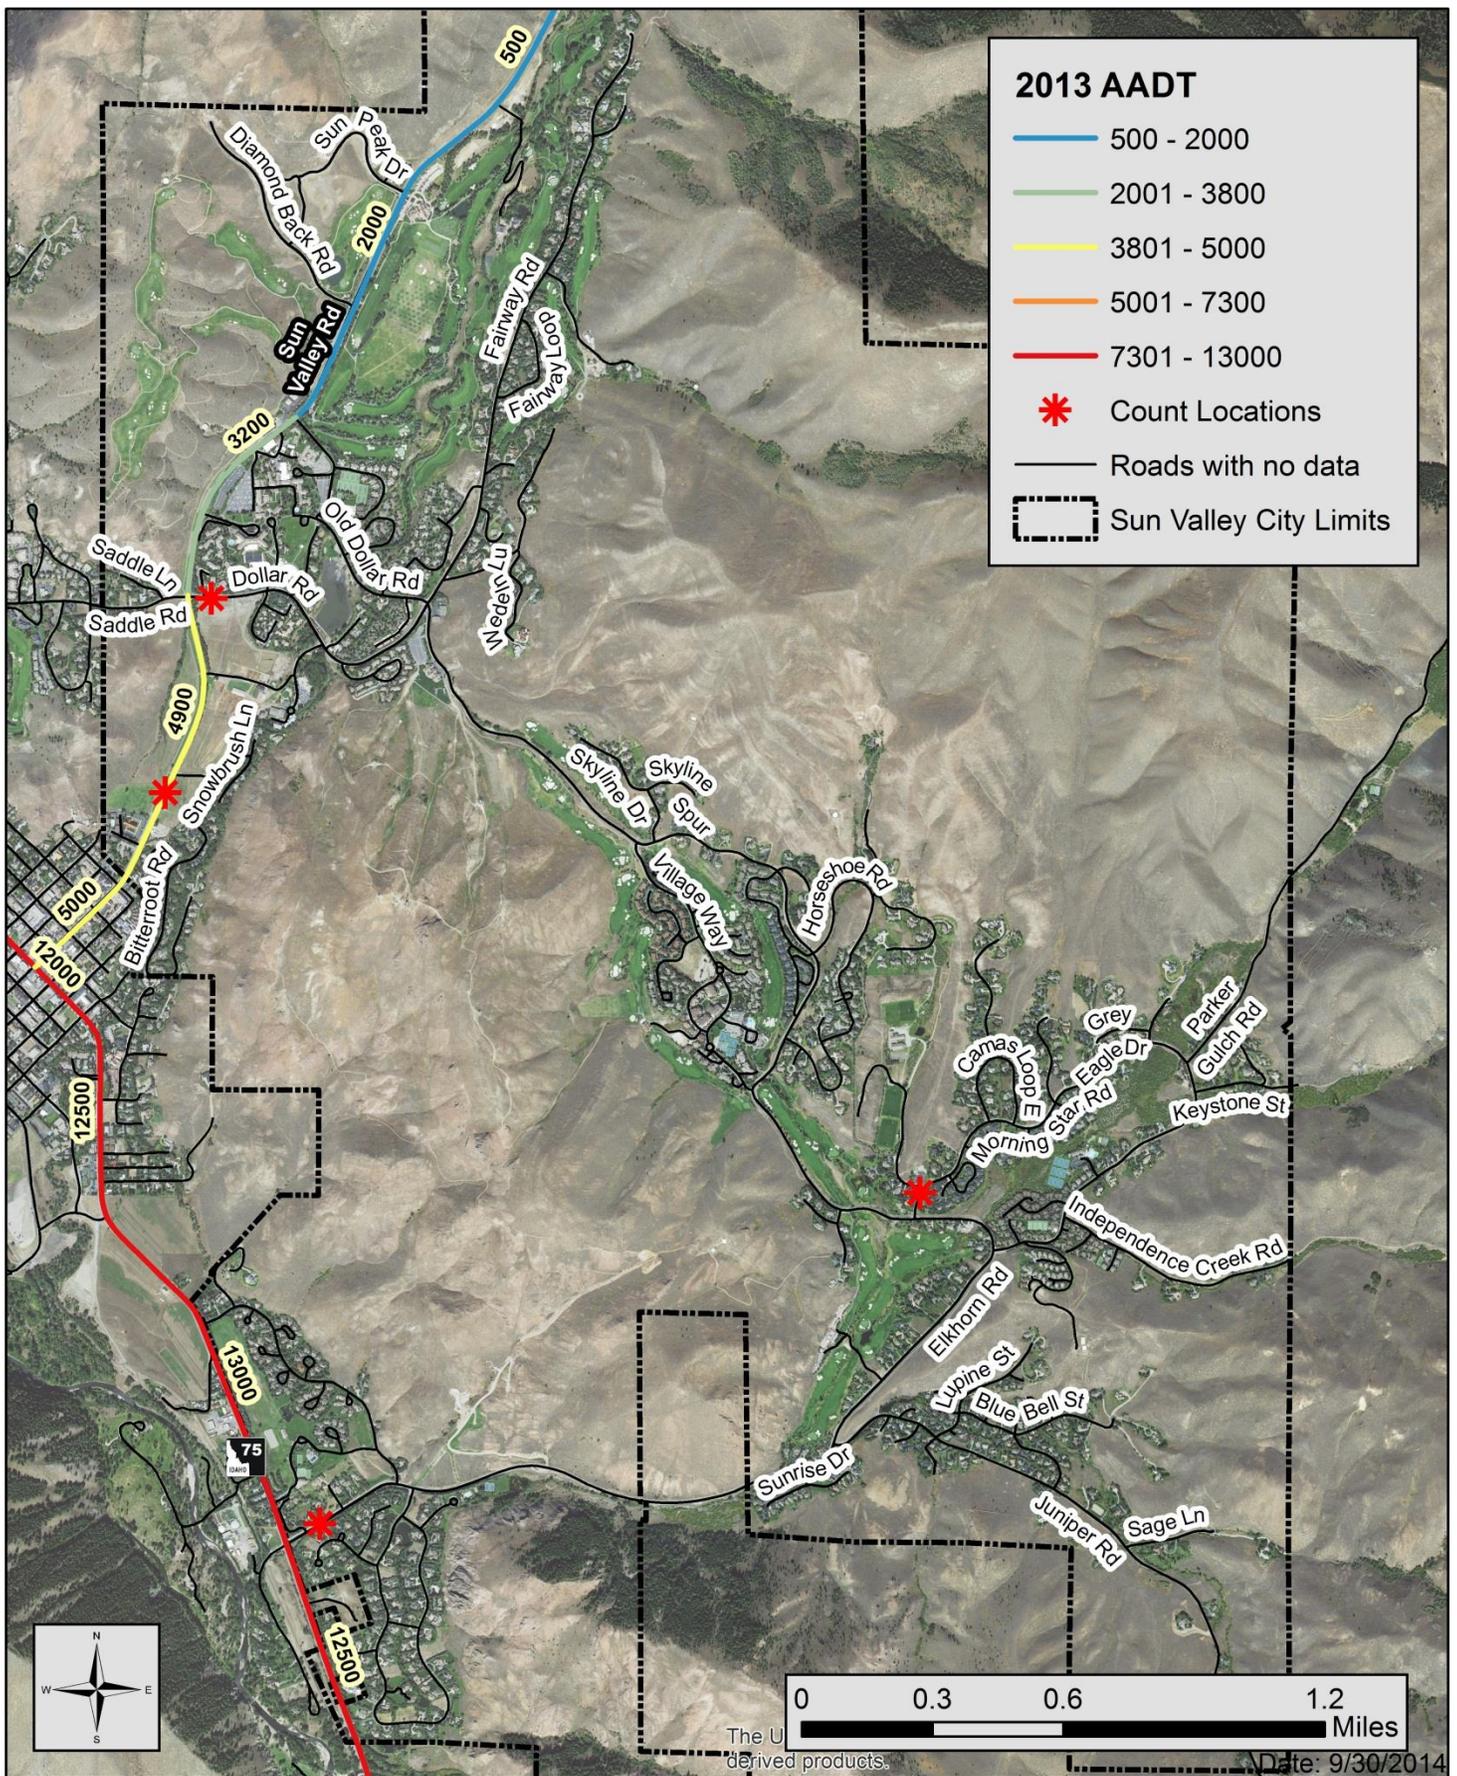
Figure 13 - Traffic Volumes

Figure 13 on the following page shows the locations of City traffic counts and 2013 Average Annual Daily Traffic (AADT) for highways obtained from ITD. City traffic counts for Sun Valley road during peak times is double that of ITD's AADT.

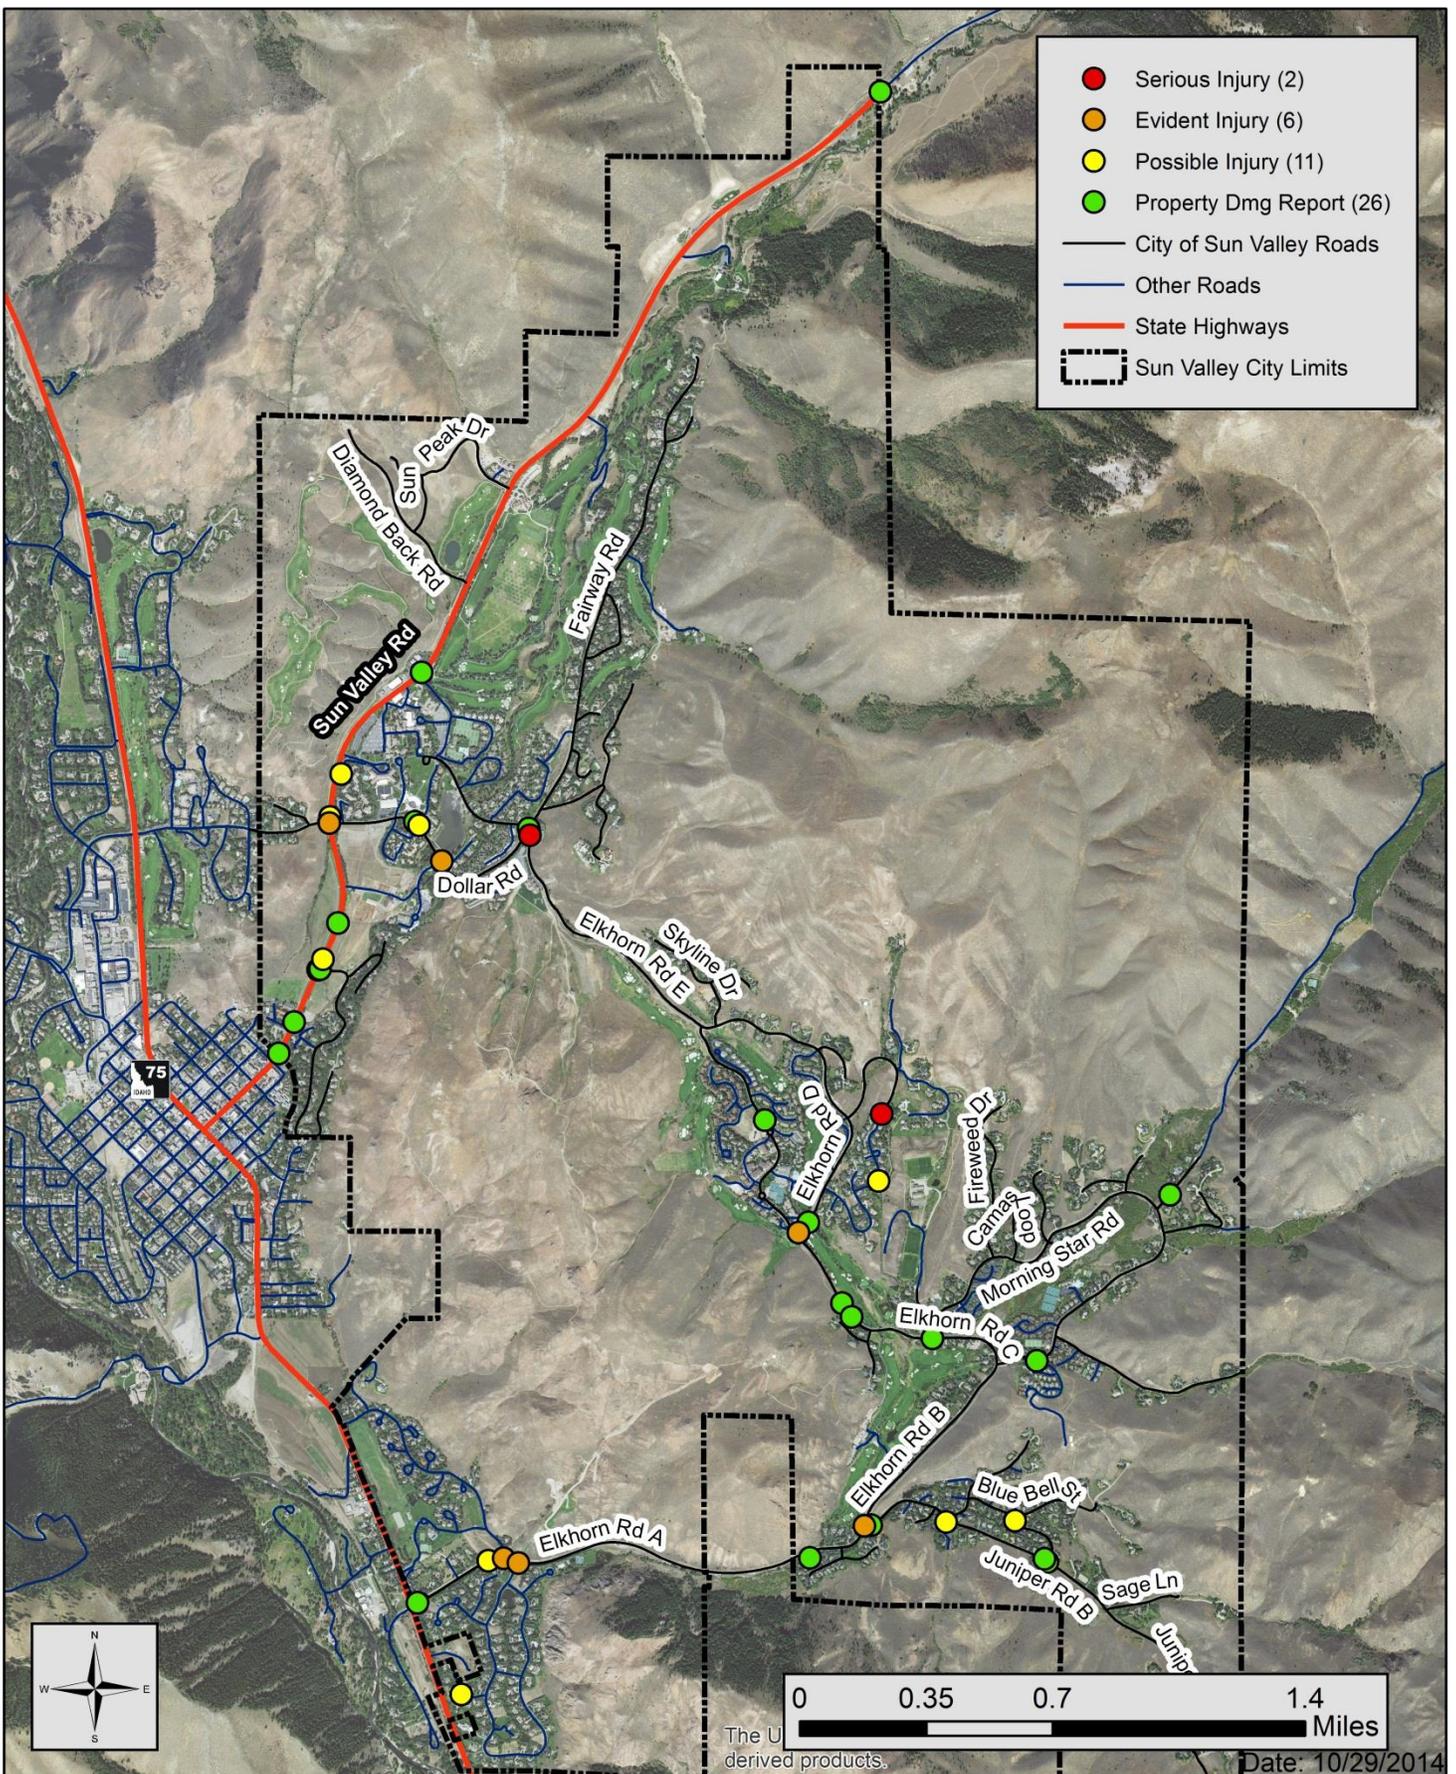
Figure 16 - 2009-2013 Crash Locations and Severity

The most common contributing circumstance was alcohol impairment. A map showing the locations of all reported crashes in Sun Valley between 2009 and 2013 can be found in Figure 16. The map is color coded to injury severity.

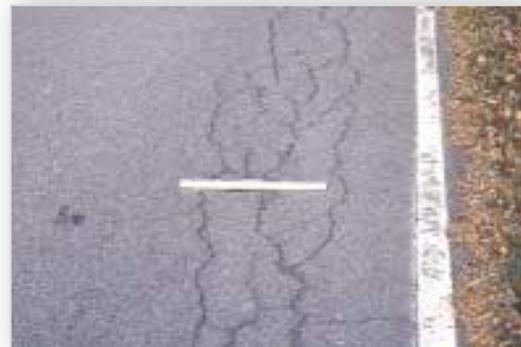
Fatigue Cracking

Fatigue cracking occurs in areas that are subjected to repeated traffic loadings, such as in the wheel path. Such wear usually results in a series of interconnected cracks that in later stages will resemble a chicken wire or alligator pattern. Some common causes of fatigue cracking are loss of base support due to poor drainage, increased heavy traffic loading, inadequate structural design, or poor compaction during construction. Due to the failure of the underlying base layer, repair by crack sealing or seal coating is generally ineffective. Fatigue cracking can be repaired by excavating localized areas and replacing the base and sub-base. Large areas of distress require reconstruction of the entire road segment. Improvements to drainage should also be considered during repair.

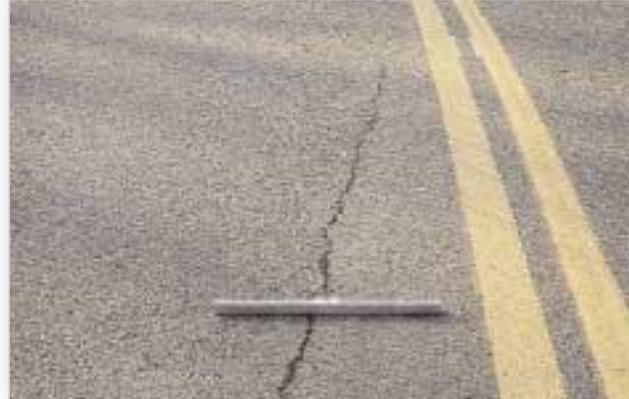
Longitudinal cracks are parallel to the pavement centerline. Centerline or lane cracks are caused by inadequate bonding during construction. They usually start as hairline cracks, and widen and erode with age. Longitudinal cracks in the wheel path indicate they may actually be fatigue cracks (see above). If caught early when the severity is low, crack sealing is an excellent repair option. However, if not addressed early they will continue to ravel, widen, develop into multiple cracks, and allow moisture to penetrate and weaken the base and sub-base.

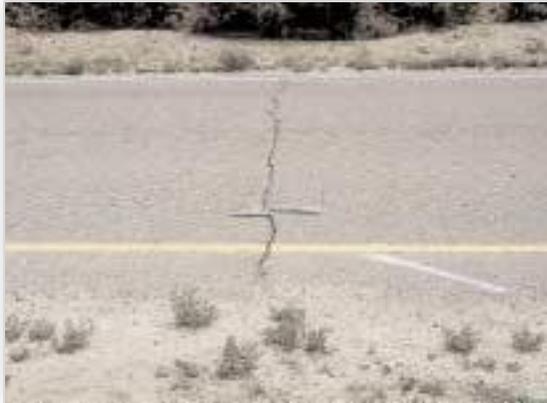
Transverse Cracking

Transverse cracks are perpendicular to the pavement centerline. They are often regularly spaced and generally caused by movement due to temperature changes and hardening of the asphalt with aging. They usually begin as hairline cracks that are widely spaced (over 50' apart). Similar to longitudinal cracks, they will continue to ravel and widen with age and should be treated early by crack sealing.

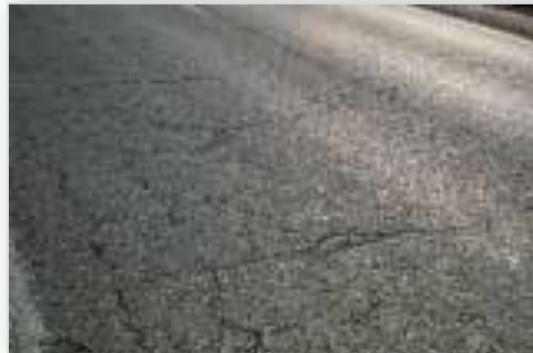
Block Cracking

Block cracks are interconnected cracks that divide the pavement -into rectangular pieces. Larger blocks are generally classified as longitudinal and transverse cracking. Closer spacing indicates more advanced aging caused by shrinking and hardening of the asphalt over time. Possible causes are usually due to the inability of the asphalt binder to expand and contract. Low severity cracks can be repaired by a crack seal. High severity cracks require a mill and overlay for repair.

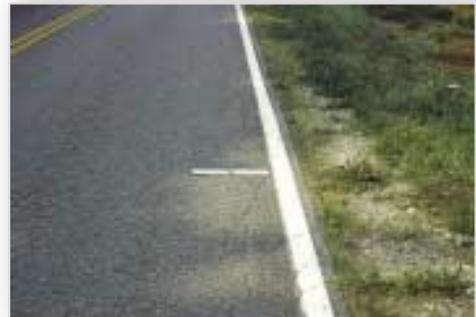
Edge cracking is the formation of crescent-shaped cracks near the edge of the road. It is caused by lack of support of the road edge, and is sometimes due to poorly drained or weak shoulders. If left untreated, additional cracks will form until it resembles alligator cracking. The appropriate treatment for edge cracking depends on its severity and extent. If caught in the early stages, crack sealing can be very effective. Once the damage has progressed, an overlay or reconstruction becomes necessary.

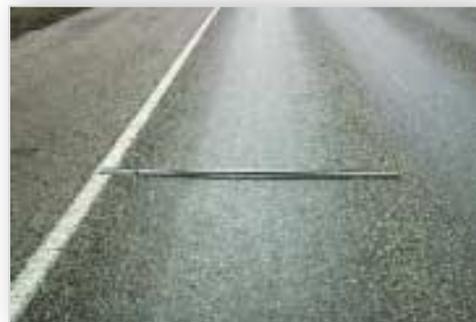
Rutting is a surface depression in the wheel path. There are two basic types of rutting: pavement rutting and subgrade rutting. Pavement rutting is usually the result of insufficient compaction during construction. If not compacted enough initially, the pavement will continue to densify under traffic loads. Subgrade rutting occurs when the subgrade fails due to settlement or lateral movement. In this case, the pavement settles into the subgrade ruts causing the surface depression in the wheel path. The method of repair depends on the type of rutting. Severe pavement rutting should be repaired by a mill and overlay. Subgrade rutting can only be repaired by replacing the entire pavement and failed base. The ruler in picture to the right is three feet long.

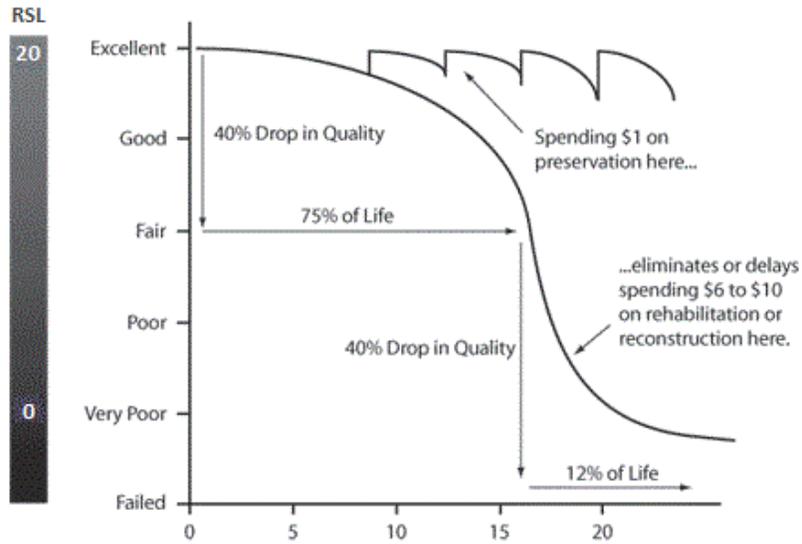
The graphic above is a generic pavement performance chart from FHWA which illustrates the idea behind pavement maintenance. By performing preventative maintenance early on in a pavement's life or once it has been restored to a like-new condition, the useful service life can be cost-effectively extended.

Most new asphalt pavements will deteriorate to a "Good" condition category after about 8 years (RSL = 12). This corresponds to a drop in the service life of the pavement of 33% and is the optimal time to apply preventative maintenance. After 12 years (RSL=8), most asphalt pavements will deteriorate to a "Fair" condition rating. This corresponds to a 60% drop in pavement life and is the optimal time to consider rehabilitation treatment. If no rehabilitation is undertaken at this point, the street will likely deteriorate to the "Poor" category within another three years (RSL=5). Cost comparisons show that reconstruction strategies cost three to five times more than rehabilitation strategies. The cost of preventative maintenance is about one-third the cost of rehabilitation strategies, or one-sixth the cost of reconstruction.

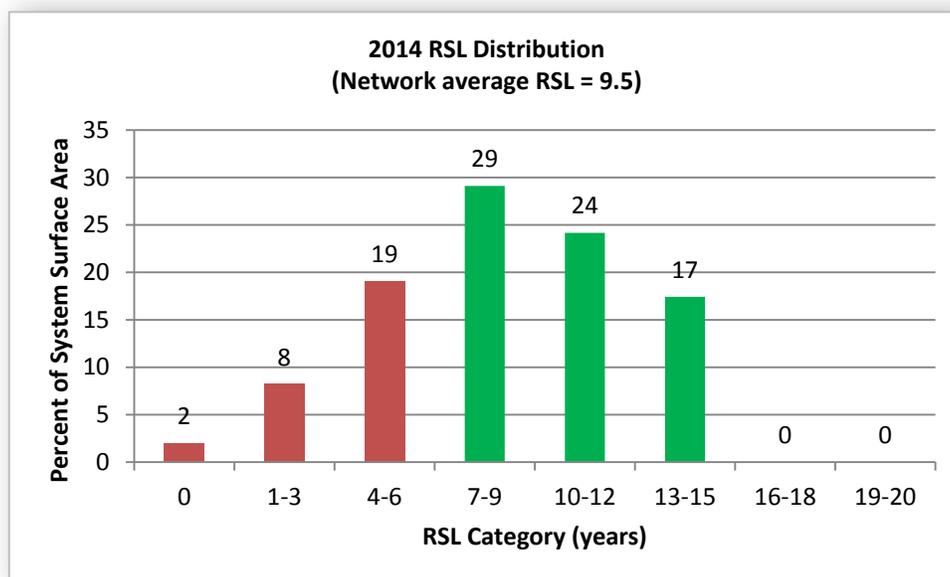
Figure 19 - 2014 RSL Distribution

The current average RSL for the City of Sun Valley’s street network is approximately 9.5 years. Figure 19 shows the current RSL distribution for Sun Valley’s street network in terms of percent of surface area of the network.

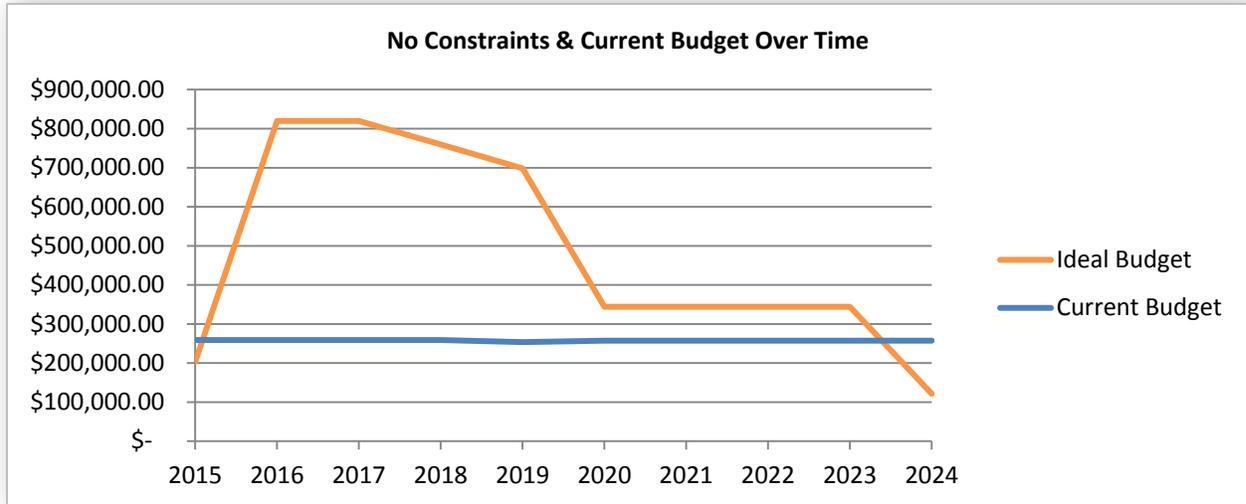
Figure 28 - Current Funding vs. Ideal Funding over Time

The current average budget (\$135k) would involve an expenditure of \$675k over 5 years, and maintain an average RSL of 8 years with over 30% of the network in poor condition by 2020. To achieve ideal characteristics in the street network, \$3.6 million would be needed over 5 years; this expenditure would provide a system average RSL of 15 years with minimal amounts of the network in poor condition. Figure 28 plots the ideal and current budget expenditures over time.

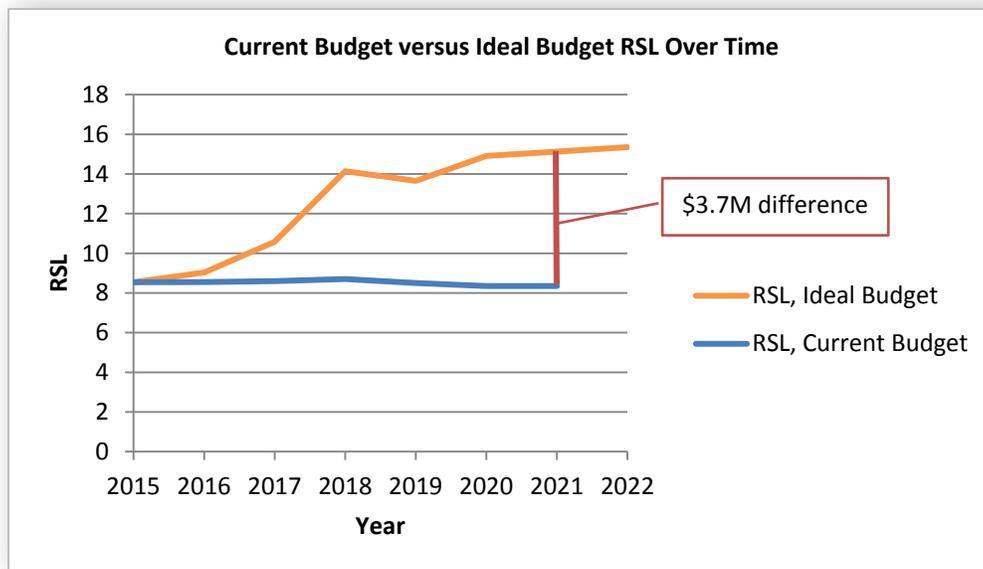
Figure 29 - Current Budget RSL vs. Ideal Budget RSL over Time

To put it in perspective, after 5 years of the current budget, \$3.7 million in a single year would be required to increase the system-average RSL from 8 to 16 years (Figure 29).

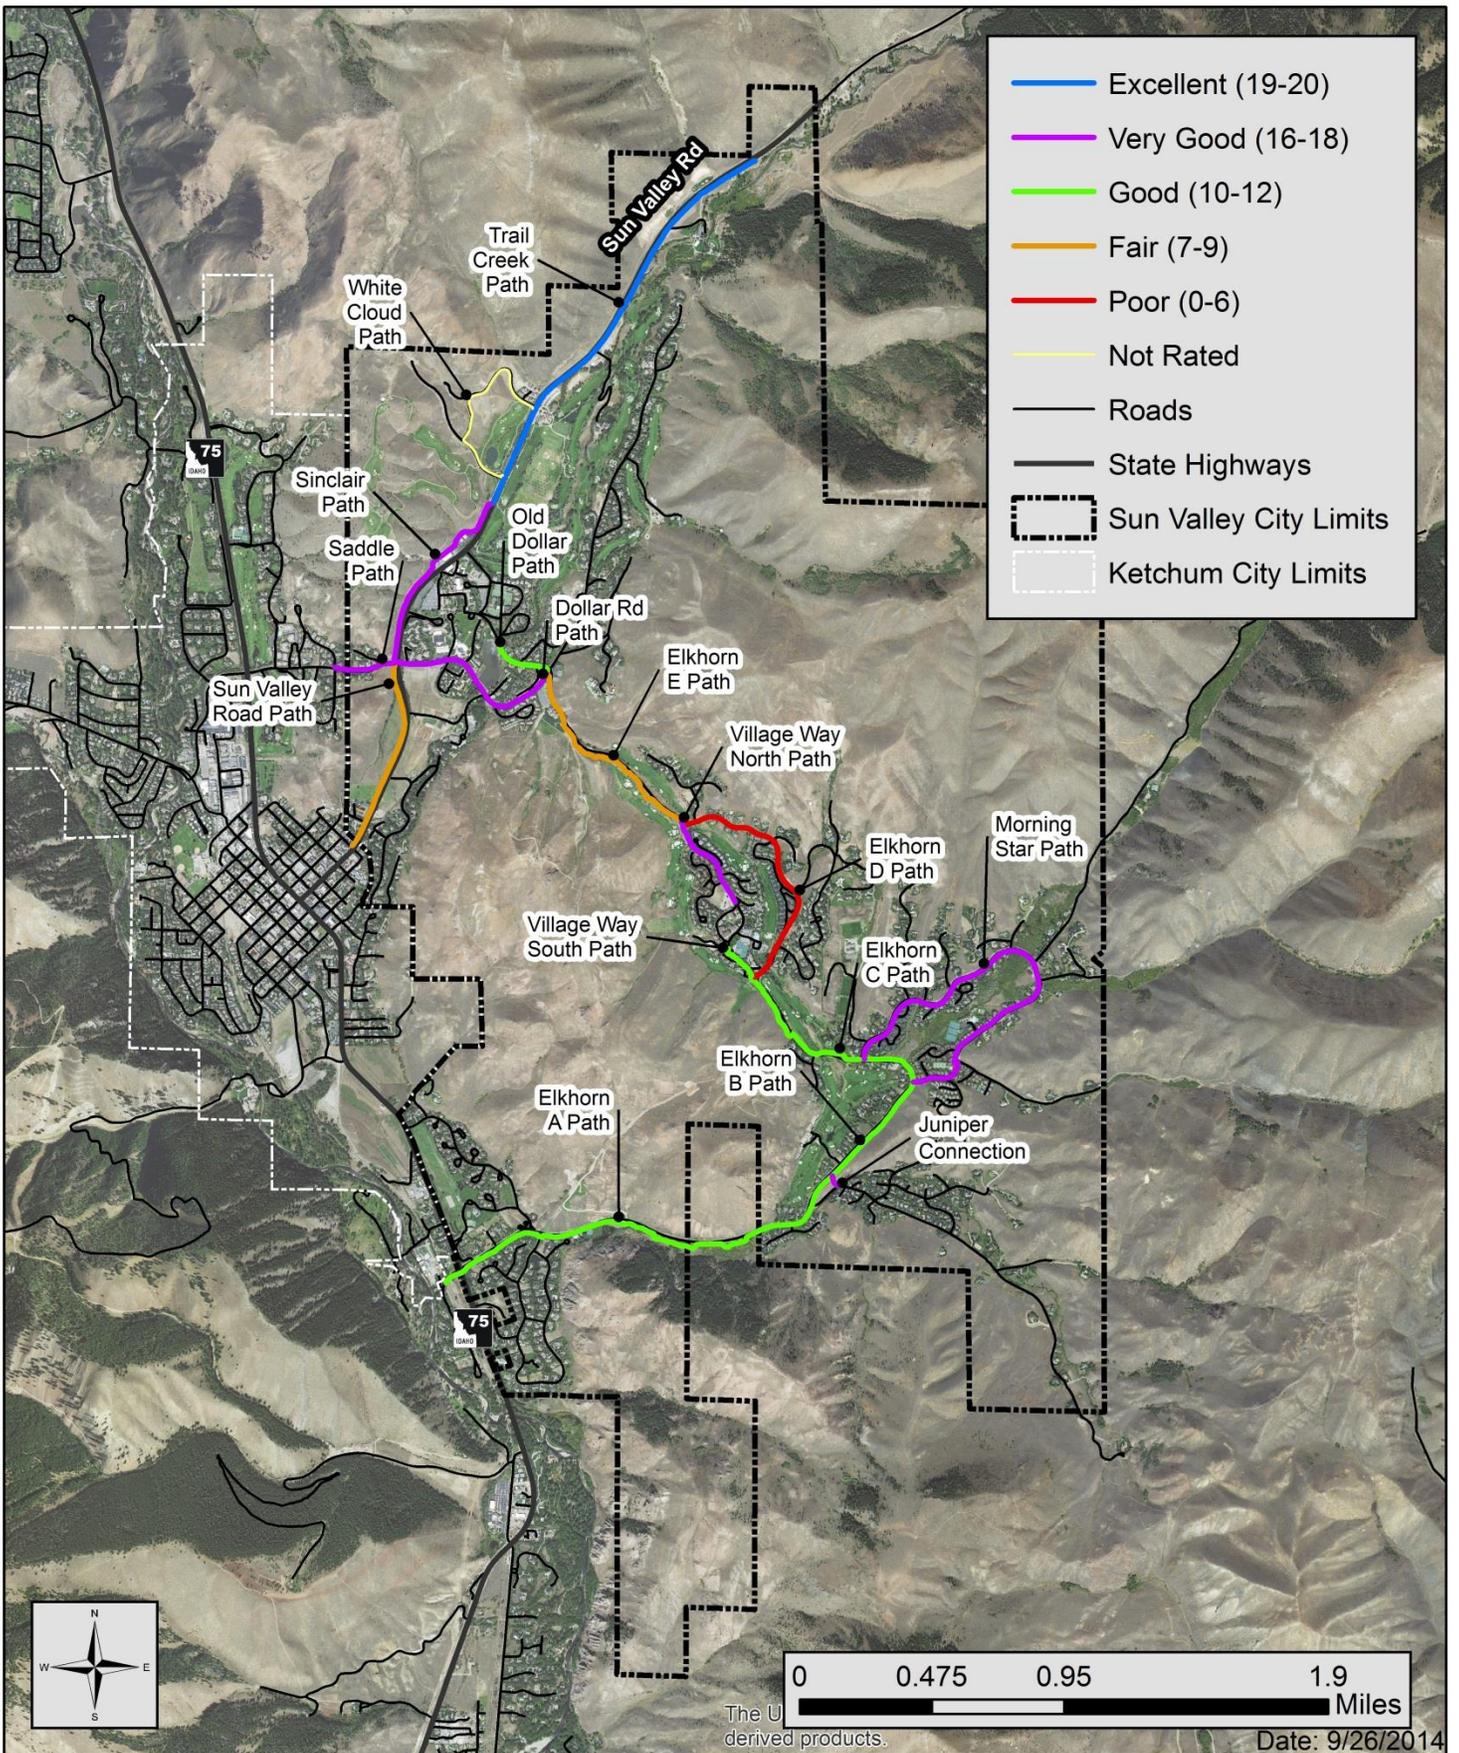
Figure 34 - 2014 Pathway Pavement Conditions

A map of pathways in Sun Valley, color-coded to condition, is shown in Figure 34.

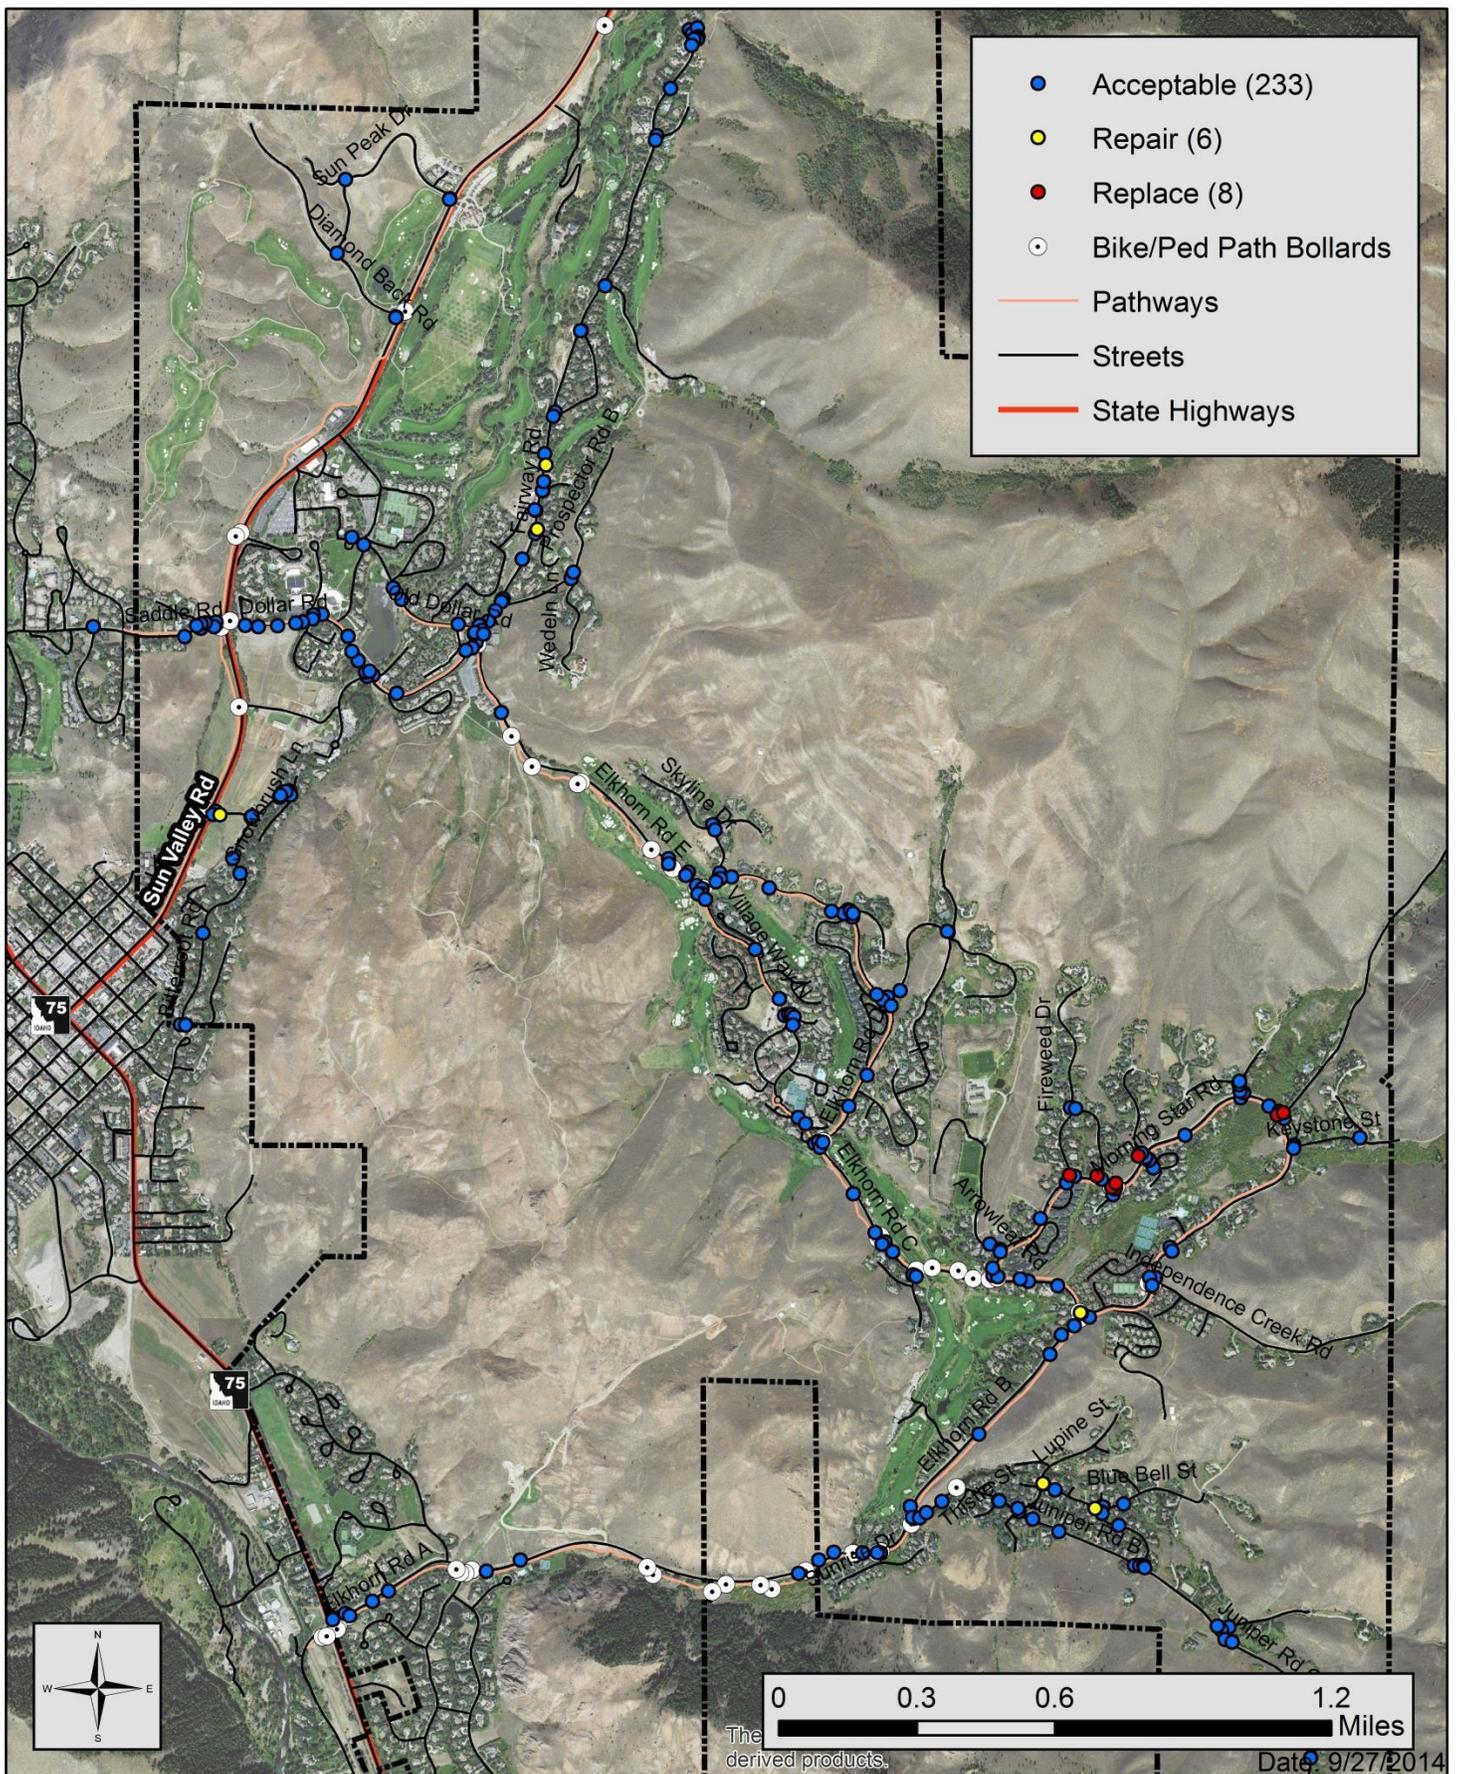
Figure 35 - Sign Post Conditions

Refer to Figure 35 and Figure 36 on the following pages for maps showing post and sign locations, color-coded to condition.

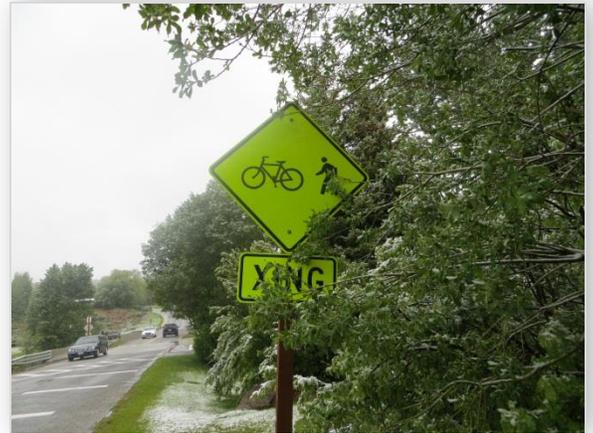
Picture 6 - Obscured Bike/Ped Sign

Sun Valley has over 245 sign installations to maintain. It is recommended that an annual spring inspection of Sun Valley’s sign installations be conducted. Some signs within the City are slightly overgrown by brush or trees. This issue was identified in the sign condition survey. Preventing sign overgrowth is an important maintenance task that can easily be overlooked. If ignored for too long, the signs will become less and less visible. The overgrowth should be identified and trimmed back during the annual sign inspection. See Picture 6 below for an example of overgrown vegetation obscuring sign visibility.

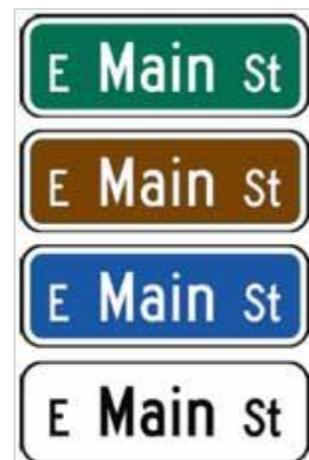
Picture 8 - D3-1 Street Name Signs

It is recommended that Sun Valley replace street name signs with retroreflective D3-1 signs (Picture 8) identified in the MUTCD, or that adequate illumination devices are added to the street name signs that currently lack them.
